NTPC Limited

Mouda Super Thermal Power Station

Reportable Incident

Location of Accident : Near TP#12 (rear side of coal pile#3, CHP)

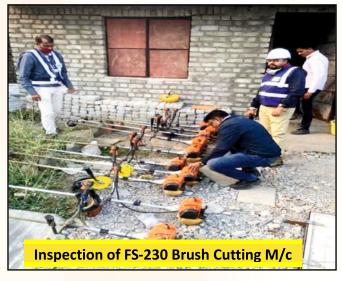
- 1) After the incident all the grass cutting machines were inspected by concerned department along with safety. It was observed that different agencies were using different cutting blades/wires.

- 2) Burrs were observed on the damage blade due to continuous usage.
- 3) As per manufacturer manual, interaction with M/s XXXX service engineer and Operators, possibility of blade breaking is minimal if checked thoroughly.

Initial Inspection of Grass Cutting Machines conducted by user dept. along with Safety.

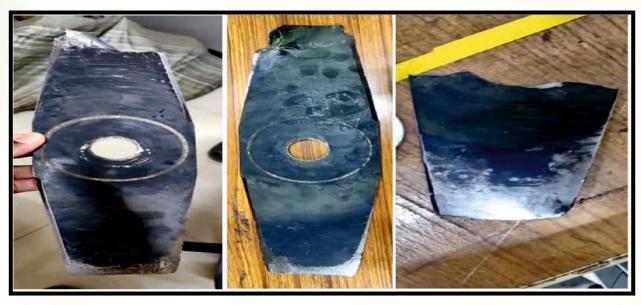
- 4) Many Operators were not aware of the proper sequence of fitment of cutting blade.
- 5) Record of training for safe operation of machine was not found for this case and other places of operation.

Some Vital Parts Missing during operation & Fitments also not in correct sequence as per manufacturer recommendations

- 5. Blades not to be changed at site in any condition by operator. It is to be changed by responsible trained person with correct procedure of OEM at designated place.
- Mandatory PPE's for operator and Safety Equipment's- Cut-resistant Gloves with anti-vibration property, FFP1 Dust mask, Ear Muffs, Safety Goggles, Gum Boots with Steel toe, Face Shields & Fire Extinguishers. Coveralls (Leather/Cut-resistant) is also suggested.

- 7. The machine to be operated with all recommended fittings as per manufacturer's instructions.

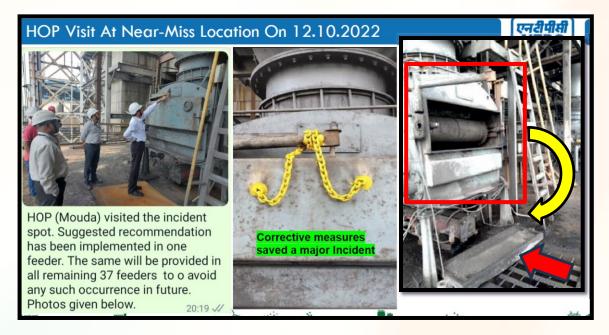
01. Near-Miss-

Reported on 12.10.2022, Unit-02 Boiler & Aux, During box up of RCF 2G Front door, hinge head got detached due to ageing and fallen on Workers Leg. #Luckily escaped with no injury.

Recommendation suggested by HOP (Mouda) implemented for all 37 feeders to avoid any such occurrence in future.

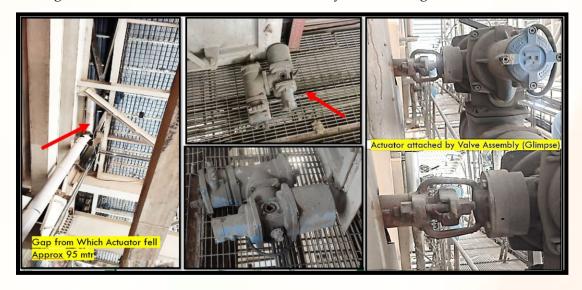
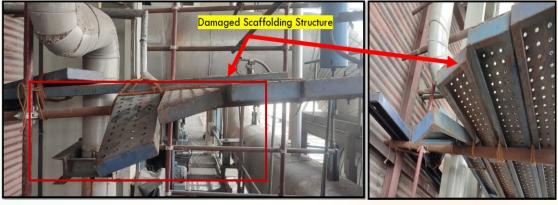
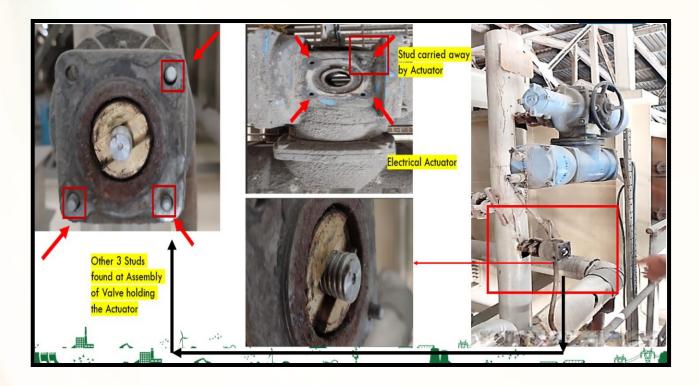
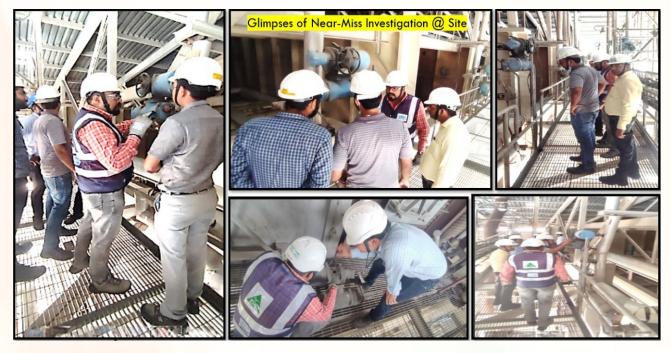
02. Near-Miss

Unit-4 SB tape off vent valve electrical actuator fallen from 90 mtr to 80 mtr. Scaffolding and piping support got damaged.

After reviewing the Site location, It seems that weight of SB TAP OFF VENT RHS Electrical Actuator, approx. 40-45 kg have been completely dependent on 4 Studs which hold the actuator, & Owing to the possibility of loosening of such studs due to certain reasons like (might have left to tighten it properly in previous Overhauling, or it may get loosened due to hammering/vibration) could resulted into such menace, self weight is catalysing factor here. Scaffolding Structure damaged very badly, We are fortunate that no one was working during that time.

Owing to the possibility of loosening of studs responsible for holding the Electrical actuators due to certain reasons like (might have left to tighten it properly in previous Overhauling, or it may get loosened due to hammering/vibration) could resulted into such menace, self-weight is catalysing factor here.

- 1) All such Electrical Actuators & other Equipment's held by such means should be checked thoroughly & re-tighten again on or before 20/06/2022 for all 4 units. (Recommended by HOP).
- 2) Preventive Maintenance Schedule should be made such that all such equipment's at a certain frequency can be inspected to prevent similar kind of incidences in mere future.
- 3) Also, one aspect of "Effectiveness of holding such equipment's" shall be explored & design of other such assemblies can be reviewed again pertaining to safety.
