NTPC Limited

Mouda Super Thermal Power Station

Reportable Incident

Location of Accident : Near TP#12 (rear side of coal pile#3, CHP)

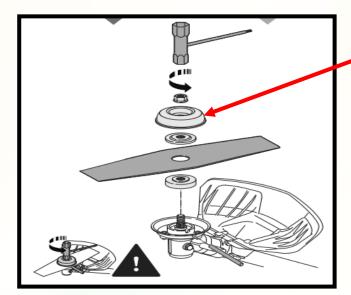
Some Vital Parts Missing during operation & Fitments also not in correct sequence as per manufacturer recommendations

- 7. The machine to be operated with all recommended fittings as per manufacturer's instructions.
